SERVICE BULLETIN

BULLETIN # 04-03
DATE: 9/5/2003
SUBJECT: 48 CONVERTIBLE
Fwd Headliner Accent Part – Reinforce Fastening Procedure
HULL #s: 09147, 31, 32, 33, 34, & 35

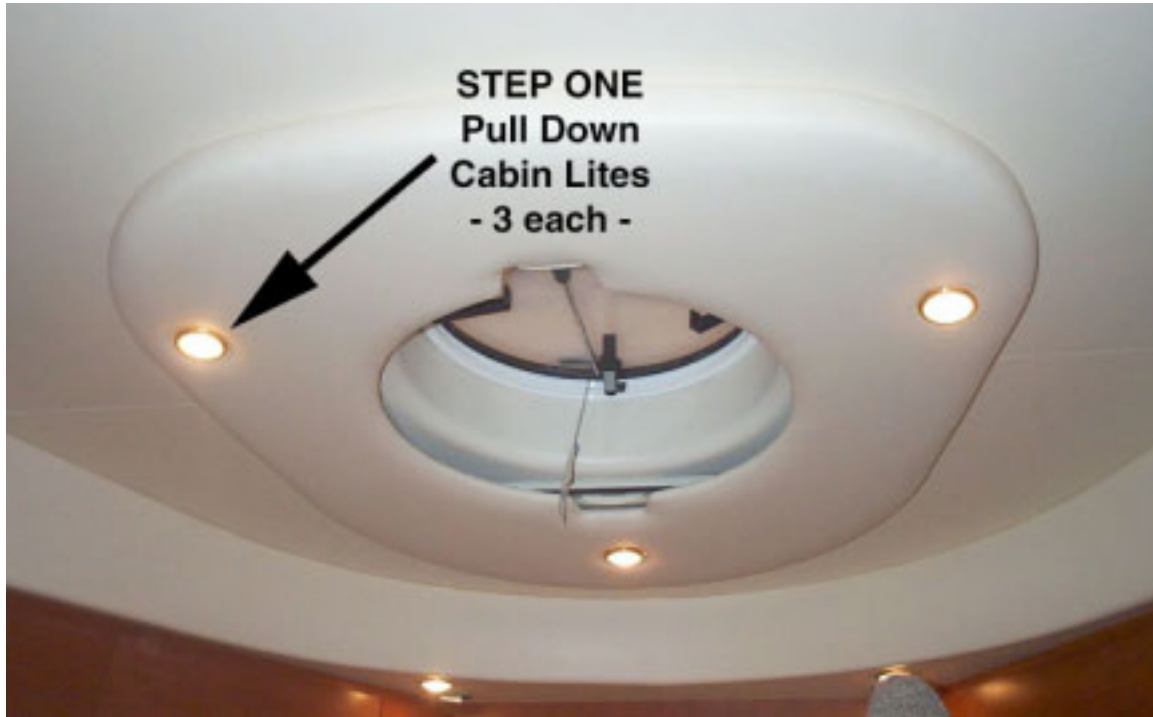
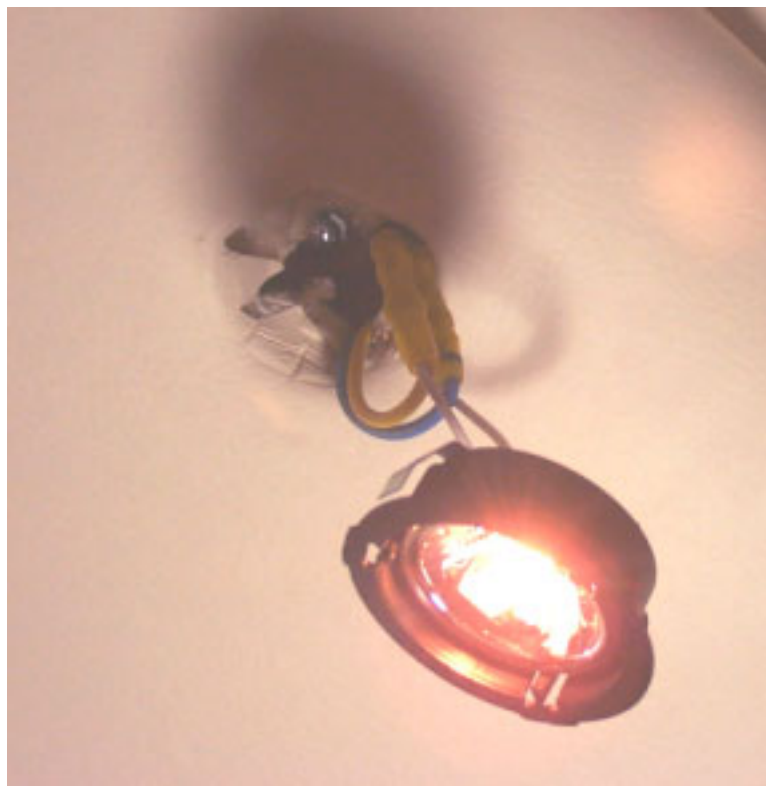
It has come to our attention that the headliner accent panel in the forward stateroom is not sufficiently secured. Over time, from the movement and vibration of boat operation it could come loose and fall.

1. Pull down the 3 cabin lights – you do not need to unhook them.
2. Drill a 1/2" hole through the plywood block above light hole and through headliner – each light hole area. *Note: Watch you don't drill wires for lights.*
3. Insert the toggle bolt through hole. Follow installation instructions
4. Use the 1/2" -20 x 1 1/2" pan head bolt to secure down tightly.
5. Reinstall cabin lights.
