# SERVICE BULLETIN

**BULLETIN # 05-04**  
**DATE: 6/30/2004**  
**SUBJECT: Central Drain Removal on Certain 410 Sport Bridge models**

**HULL #s: All Diesel Installations with Hull Numbers from #31 to #66**

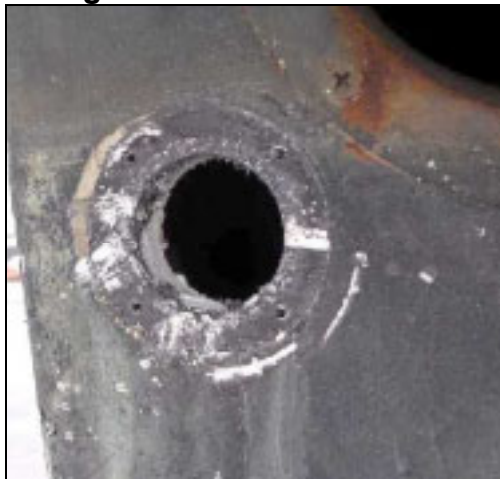
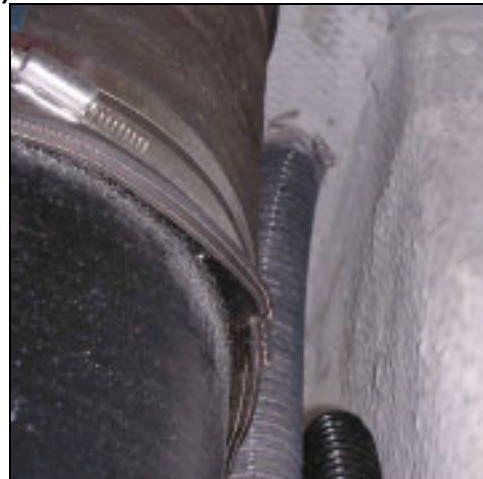
**Figures 1 and 2- Central Drain Thru-Hull Location- Port Transom**

A certain number of early 410 Sport Bridge models were originally equipped with a central drain system. This system consists of a PVC pipe running down the port side of the bilge, with hose connections for bilge pumps, air conditioning units, and sink drains. The pipe leads to a plastic thru-hull, located on the port side transom, below the waterline. Due to safety concerns, we are requesting that the following service be performed to the 410 Sport Bridge models listed above.

1. The boat will need to be on land and blocked in order to perform service. If the boat is in the water, pull the boat out of the water and securely support it, so that you have access to the transom and hull sides.
2. Detach the hose connecting the central drain to the thru-hull located on the port side of the transom. Remove the thru-hull, and patch the existing hole in the transom. The PVC central drainpipe will remain in the boat even though it will not serve any function. (Please See Figures 1 and 2 for Clarification)
